ENHANCING GEOTECHNICAL INFORMATION WITH GROUND PENETRATING RADAR

Marc Fish

New Hampshire Department of Transportation,
Bureau of Materials and Research,
Box 483, Stickney Avenue, Concord, NH 03302-0483
mfish@dot.state.nh.us

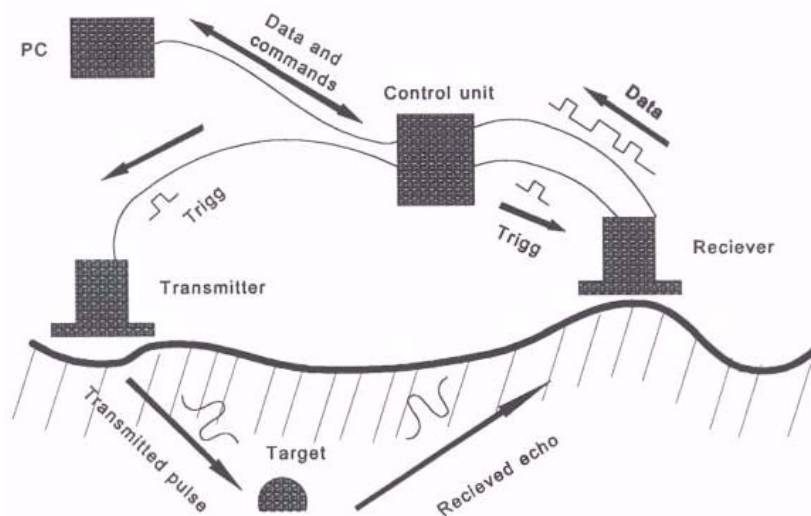
Figure 1: GPR schematic. The radar control unit is connected to a laptop computer through a parallel communications cable and to the transmitter and receiver through fiber optic cables.

GPR operates by transmitting pulses of radio waves down into the ground through an antenna. The transmitted energy is reflected from contacts between different earth materials. When the transmitted signal enters the ground, it contacts subsurface strata with different electrical conductivities and dielectric constants. Portions of the radar waves are reflected off a subsurface interface, while the rest of the waves pass through to the next interface. The digital control unit receives the reflected waves after they have returned through the antenna. The control unit registers the reflections against a two-way travel time, then amplifies the signals and sends them to a computer. The computer takes the output signals, representing reflected surfaces, and plots them on the radar profile as different color bands.

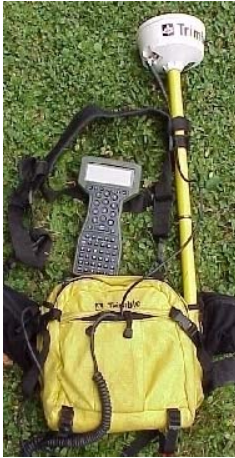
Figure 7: Trimble ProXR GPS

When the survey wheel was unable to track the distance traveled, a Trimble GPS (Figure 7) was used. This was particularly useful for obtaining the locations of profiles collected over water. By collecting the positional data with the GPS, the locations of the profiles could easily be placed on the project plans. A laser profiler (Figure 8) was also used to help locate seams and fractures on the face of a rock cut and a digital camera (Figure 9) was used to help document pertinent project information.

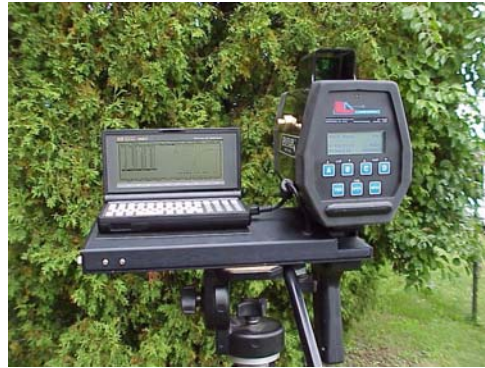
Figure 8: Laser gun & profiler

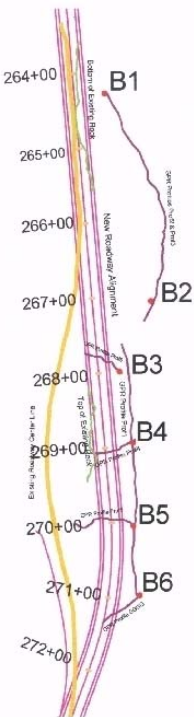
Figure 13: Map view showing test borings & GPR locations with both roadway alignments

Route 112 is a two-lane highway within the White Mountain National Forest (Figure 10). A project is proposed to resurface and straighten six kilometers of this highway. Test borings were conducted at several key areas of the project. One such area was approximately 300 meters of new roadway alignment that went into the woods, eliminating a large curve in the road. Six test borings were conducted along the new alignment. At locations between the test borings the depth to bedrock became a concern when the test boring data, the surface topography and the existing rock outcrops were all examined. GPR was deployed to address this concern and to determine the depth to bedrock within these areas (Figure 11). The test boring data revealed relatively clean sands and gravel over bedrock of varying depths. GPR profiles were collected over varied terrain with an outside temperature of 15°F (Figure 12). The 100 MHz antenna was used because the depth to bedrock was expected to be greater than four meters in many locations. Two profiles were collected parallel to the new alignment and four profiles were collected perpendicular to the new alignment, which would aid in drawing the bedrock lines on the project cross sections. Survey stationing had not been placed in the field so a GPS receiver was used to locate where the profiles had been collected and where the test borings had been conducted. The positional data for the test borings and the profiles were viewed on the project plans using ArcView GIS (Figure 13). Bedrock lines were drawn on the project cross-sections by correlating the profile and test boring data and by viewing their locations in regards to the centerline stationing on the project plans.

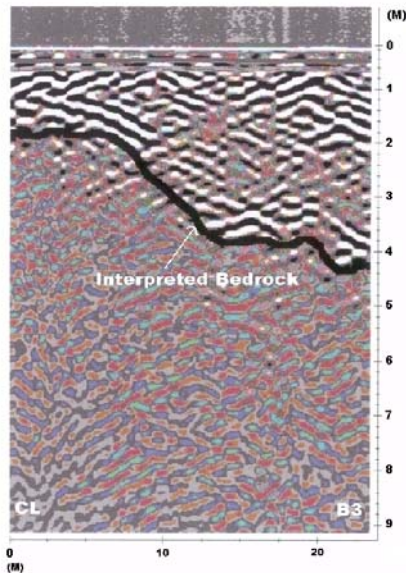
Figure 14: GPR profile, going from EOP to B3 perpendicular to the roadway alignment

The radar profiles were calibrated using the test boring data by adjusting the velocity of the radar waves to match the depths at which the test borings intercepted the bedrock. Figure 14 is a GPR profile perpendicular to the roadway alignment, without topography correction, showing the interpreted bedrock line starting from the edge of pavement and going to boring B3. Figure 15 is the profile collected by pulling the radar unit from test borings B6 to B3, parallel to the roadway alignment. Boring B6 encountered bedrock at a depth of 3.4 meters, B5 at a depth of 3.4 meters, B4 at a depth of 1.2 meters and B3 at a depth of 4.0 meters. Both of these profiles demonstrate how GPR was able to provide detailed subsurface information in the areas between and adjacent to the test borings. This helped with the design of the cut slope over this section of the new roadway alignment.

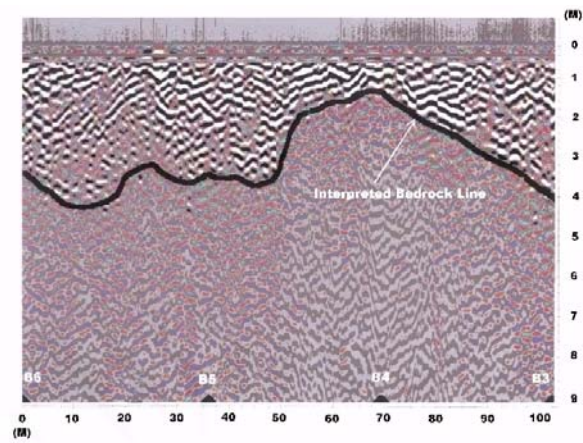
Figure 15: GPR profile between test borings B6 & B3, parallel to the roadway alignment

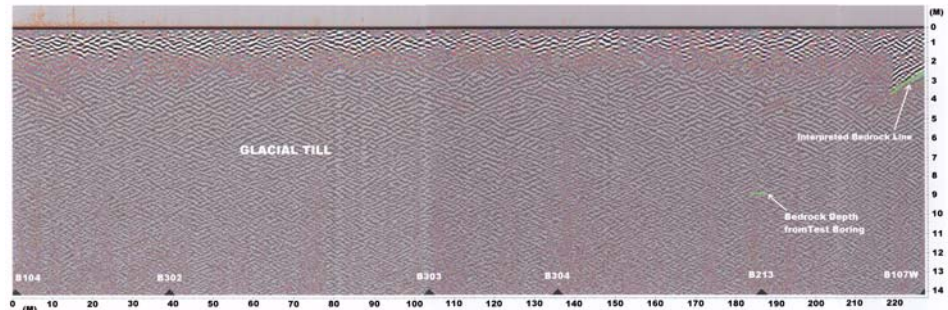
Figure 17: Test borings indicate that bedrock rises from below the profile bottom on the left to a depth of 3 meters at the right. The glacial till was absorbing the radar energy below 4 meters of depth

Figure 17 is a radar profile collected from the first location along the new roadway alignment. At this location large roadway cuts of approximately 14 meters are proposed and accurate bedrock depths are required in order to make the appropriate roadway cut designs. At one end of the cut the test borings indicated that bedrock was relatively deep, approximately 17 meters, and at the other end of the cut they indicated it was relatively shallow, approximately 3 meters. The profile indicates that the radar waves were unable to penetrate the glacial till beyond a depth of approximately 4 meters. The only location where bedrock appears on the profile is where it rises above 4 meters in depth, which is along the last 15 meters of the profile. Three additional test borings were placed along this new alignment to confirm the depth to bedrock between test borings B104 & B213. Figure 18 is another radar profile collected from a different section of the new roadway alignment. Roadway cuts of approximately 6 meters are to occur in this area. At this location the bedrock is around 2 meters in depth, rising higher in some places and lower in others. Bedrock depths taken from the test borings were used to help calibrate the profile's depth scale. B120 encountered bedrock at 2 meters, B119 at 1.4 meters, and B118 at 1.2 meters. The profile's interpreted bedrock line closely matches the depths at which the test borings encountered bedrock, except at boring B118 where the exact location of the test boring could not be identified because of snow cover. At this location the radar unit must have been pulled nearby the test boring and not actually over it.

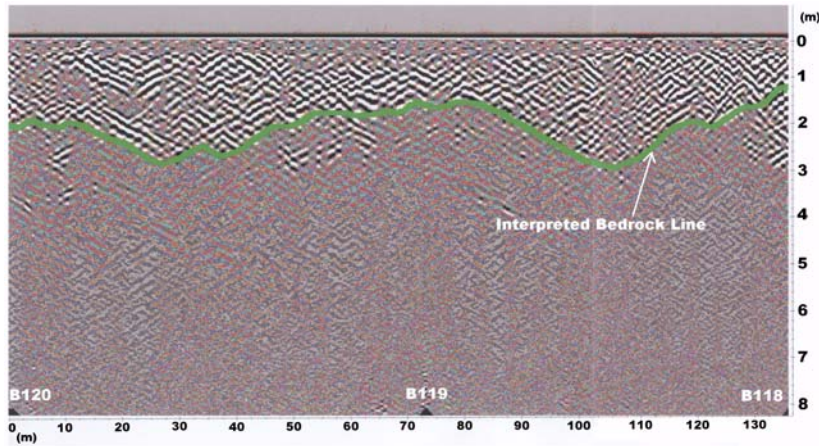
Figure 18: The interpreted bedrock line from the radar profile correlating well with the test boring data

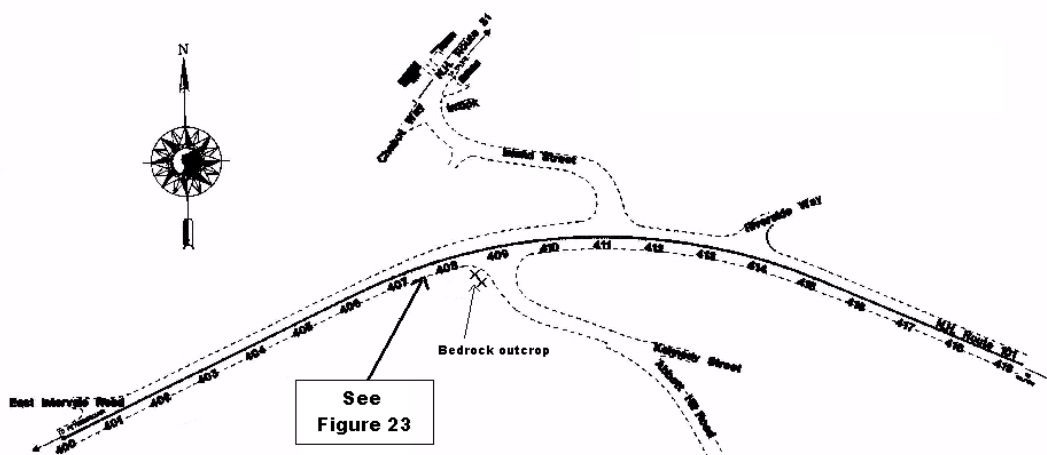
Figure 19: Copy of “as-built” plans minus some of the details

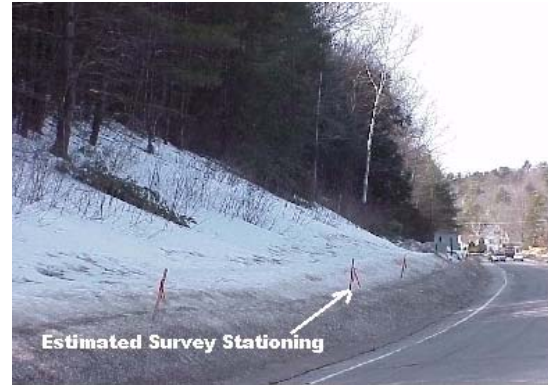
Figure 21: The roadway embankment showing the estimated survey stationing from the “as-built” plans

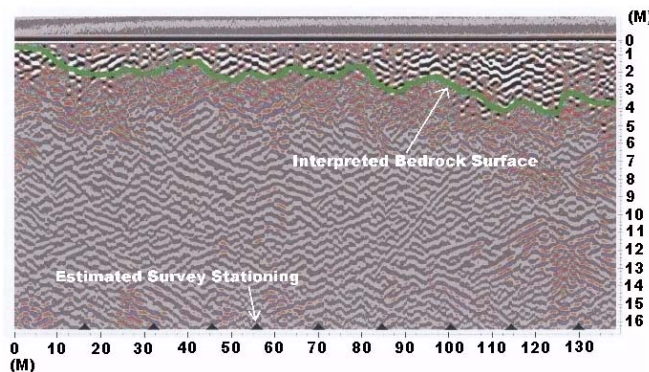
Figure 22: Interpreted bedrock line with the estimated survey stationing for the profile collected along the embankment

Figure 22 is one of the profiles collected at the site. The green line represents the interpreted bedrock surface and the marks at the bottom of the profile are the estimated survey stationing from the old “as-built” plans. In order to help determine where bedrock was displaying on the profile the radar unit was started near the corner of the intersection where bedrock was very close to the ground surface. The interpreted bedrock line was drawn at the boundary between the two distinct surfaces shown on the profile, except at the beginning of the profile where our assumption of having bedrock close to the ground surface was used. During the construction phase of this project bedrock was encountered within the cut slope. Accurate elevations of the exposed bedrock surface were obtained and plotted on the cross sections with the original ground surface, the new ground surface, and the interpreted bedrock line (Figure 23). The cross section shown in Figure 23 displays how closely the interpreted bedrock line follows the actual bedrock surface measured during the construction phase of the project.

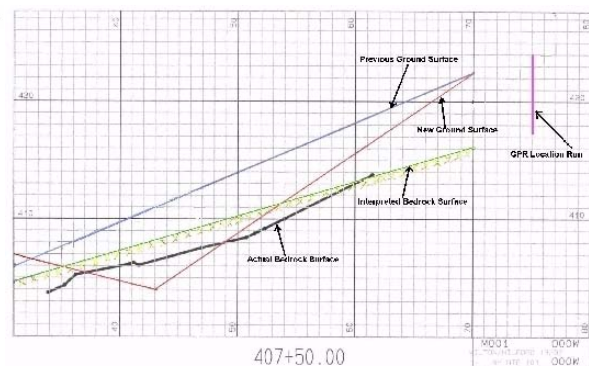
Figure 23: One of the final cross-sections showing the different surfaces and the actual location of where the GPR profile was collected

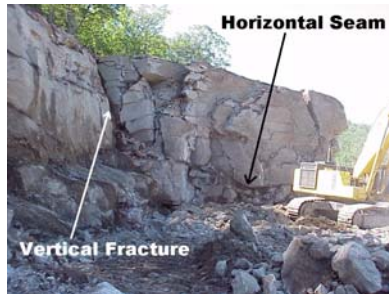
Figure 24: Horizontal seam and vertical fracture

Two weeks prior to bid advertisement, work within a rest area was added to a large interstate highway project. The additional work involved increasing the parking capacity of the rest area by cutting back a large unstable rock slope and rehabilitating the existing rest area building. Time constraints ruled out the possibility of conducting a geotechnical investigation so a site reconnaissance was done to estimate the amount of soil cover over the existing bedrock. During construction the rock cut's stability became a concern because vertical fractures and large seams, dipping towards the parking area, were uncovered. Figures 24 through 26 are photographs showing the dipping seams and the vertical fractures

along the face of the cut. Severely weathered rock and soil filled the seams and water was often flowing from them. A drill rig was mobilized in an attempt to locate the seams at a predetermined offset behind the face of the cut. A laser profiler was used to determine the elevation of the seams exposed on the face of the cut and GPR was used to locate the seams at areas between and adjacent to the test boring locations. The radar profiles were calibrated using the test boring and laser profiler data while existing survey data provided ground elevations for topography corrections above the cut.

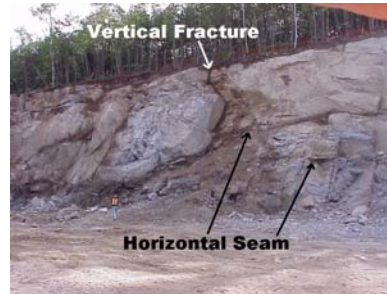
Figure 25: Horizontal seam and vertical fracture showing a detached slab

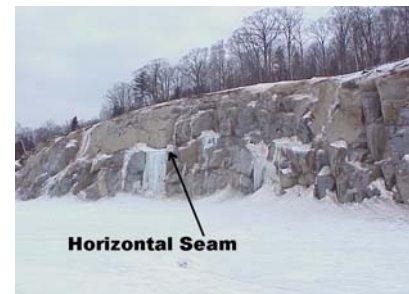
Figure 26: Frozen water flowing from horizontal seam

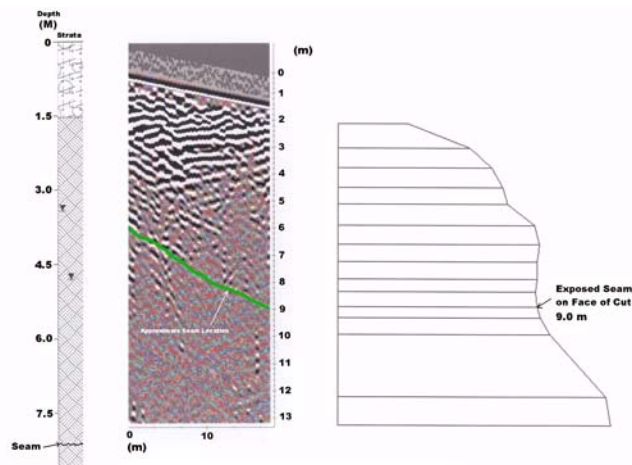
Figure 27: Test boring log, GPR and laser profiles for station 709+50

Figures 27 through 32 show the test boring logs, the laser profiles with seam locations, and the topography corrected GPR profiles, which start at the tops of the laser profiles and end at the test borings. By observing the depths where the seam intersects the face of the cut, where the test borings intersect the seam, and where the seam is detected on the profiles, it was deduced that the seam is continuous and dips towards the parking area. This geological investigation collected enough information to demonstrate that changes in the design of the cut slope and parking area were warranted to address the stability of the rock cut.

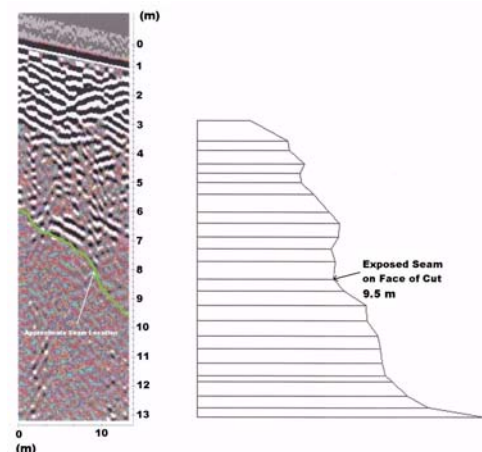
Figure 28: GPR and laser profiles for station 710+00

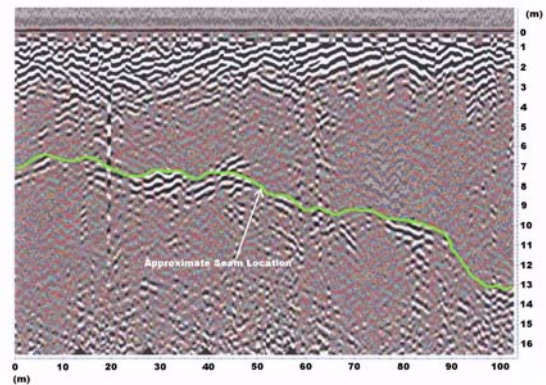
Figure 32: GPR profile parallel to the face of the cut depicting the seam

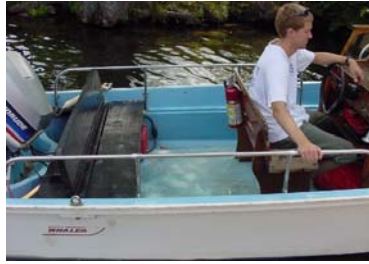
Figure 34: The radar antenna was placed behind the seat

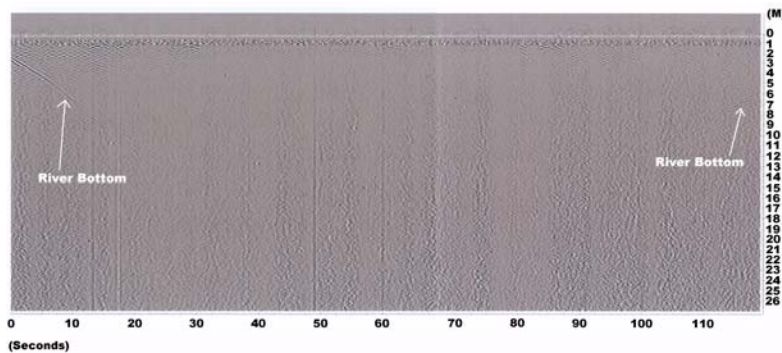
Figure 36: River bottom profile from VT side of river, going east to west. The river bottom is only visible on the sides of the river

Two profiles were collected at this site using the 100 MHz antenna. The data acquisition mode was changed from distance to time because the survey wheel was not being used as a trigger source for data collection. The river water was cloudy and contained a fair amount of sediment and visibility was limited to about a meter. Figure 36 shows the profile collected from the channel closest to the Vermont side of the river. The radar waves penetrated through the water down to a depth of about 7 meters and maybe another meter or two into the sediment. The river bottom is only visible at the beginning and at the end of the profile, which correlates to the edges of the river where the water depth is minimal. Towards the middle of the profile the depth of the water becomes greater than what the radar signal can penetrate and the river bottom is no longer visible. Figure 37 is the profile collected along the channel closest to the New Hampshire side of the river. Like the profile on the Vermont side, the river bottom is only visible at the beginning and at the end of the profile. Towards the middle of the profile the radar energy is attenuated before it reaches the bottom of the river. The high amount of suspended sediment in the river along with the water depth provide likely explanations for not detecting river bottom reflections away from the banks of the river.

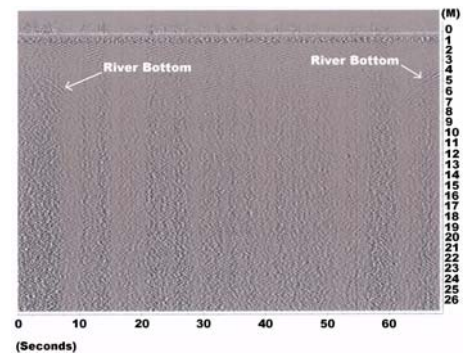
Figure 37: River bottom profile from NH side of river. The river bottom is only visible on the sides of the river

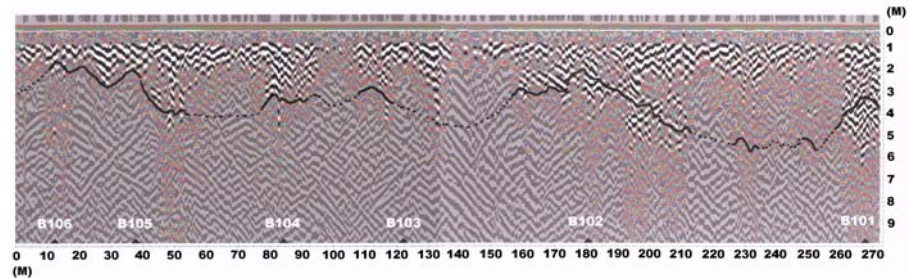
Figure 39: Profile along embankment, solid line indicates bedrock was confirmed with test borings, dashed lines are estimated bedrock surfaces

Figure 38 is a photograph of the road depicting where the subsurface investigation was undertaken. A 783-meter profile was collected along the left-hand side of this road using the 100 MHz antenna. Figure 39 is a portion of the profile collected in the area of where the existing embankment will be cut back. The profile was collected at the base of the cut slope a few meters away from the test borings

locations and 2.5 meters lower in elevation. There were buried utilities along the base of the cut slope within a couple of meters from where the profile was collected. The 2.5-meter elevation difference was subtracted from the test boring data so the radar and test boring data could be compared. The profile appears to correlate with the test boring data at borings B106, B105 and B104 but does not correlate with the test boring data at borings B103, B102 and B101. At some of the locations between the test borings, the validity of the radar data appears to be questionable. The profile's interpreted bedrock line is solid where the correlation between the test boring and GPR data is good and dashed where the correlation is poor.

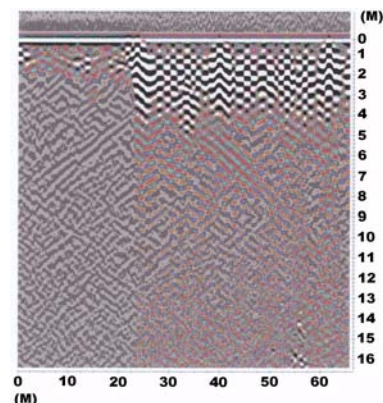
Figure 41: Intersection Profile. Notice profile change from asphalt to concrete

This roadway project involved the enlargement of the intersection shown in figure 40. To determine what the soil and bedrock conditions were at this site a subsurface investigation was conducted by drilling test borings and collecting GPR profiles. The profiles that were collected off the roadway surface indicated that bedrock was shallow and nearby test borings confirmed this. These borings encountered bedrock along the left hand side of the road at 1.0 meter and along the right hand side of the road at 3.4 meters. To determine if bedrock would be encountered within the middle of the intersection several GPR profiles were collected. Traffic concerns eliminated the possibility of drilling test borings in the middle of the intersection for bedrock depth confirmation. Figure 41 is a profile collected by pulling the radar unit down the center of the road shown in figure 40. It starts on the pavement and goes onto the concrete median for a total length of 70 meters. When comparing the pavement section of the profile to that of the concrete section there is a distinct difference in signal penetration. Since this investigation was conducted during the spring it is believed that dissolved roadway salt inhibited the penetration of the radar signal into the pavement. The difference in signal penetration makes the interpretation of the profile extremely difficult.

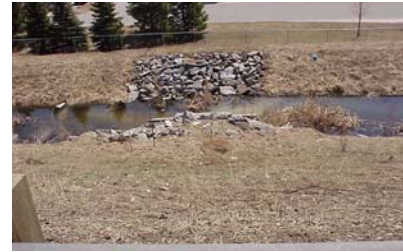
Figure 44: Test boring wash water emerging at base of embankment

This project was initiated because of an embankment failure along a relatively new section of roadway located on top of an embankment fill (Figure 42). On the other side of the road and opposite the embankment failure voids were opening up on the ground surface (Figure 43). To determine if the roadway was in danger of failing or if voids existed below the roadway surface a drill rig was mobilized to drill holes through the pavement and the radar unit was set up to collect GPR profiles. It became apparent that water could easily travel beneath the roadway surface and through the fill because wash water from the drilling operations emerged from around a drainage pipe located at the base of the embankment (Figure 44).

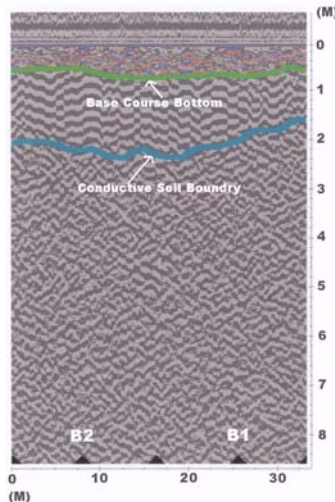
Figure 47: GPR profile

The profiles shown in figures 45, 46 and 47 were collected using the 500 MHz antenna and the profile shown in figure 48 was collected using the 100 MHz antenna. The profiles in figures 45, 46 and 47 show the bottom of the roadway's base coarse material and a soil boundary layer a meter or two lower in elevation. The marks at the bottom of these profiles represent the test boring locations. The profiles going from B4 to B2 (Figure 45) and B3 to B1 (Figure 46) are perpendicular to the roadway alignment and the profile going from B2 to B1 (Figure 47) is parallel to the roadway alignment. The profile in figure 48 was run parallel to the roadway alignment, six meters from the edge of pavement and next to the surface voids that are shown in figure 43. The marks at the bottom of this profile represent the location of the surface voids. The test boring logs (Figure 49) indicate that silty fine sands with layers of clay and gravel compose most of the embankment fill. Riprap or larger stone was not found to be present anywhere within the embankment fill and neither GPR nor the test borings detected any subsurface voids. It appears that water flows from one side of the embankment fill to the other along the detected soil boundary and as it exits it washes out the side of the embankment.

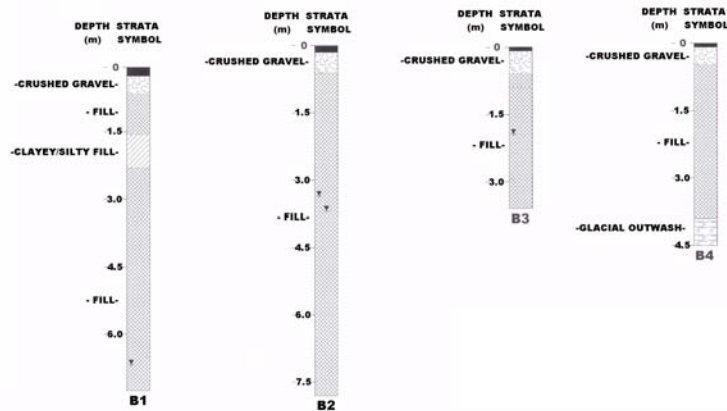
Figure 49: Test boring logs for the above GPR profiles (Figures 45-48)
